POPPLETON HISTORIC STUDY

B-2687 MAGI #0476875501

1018-1032 Boyd Street

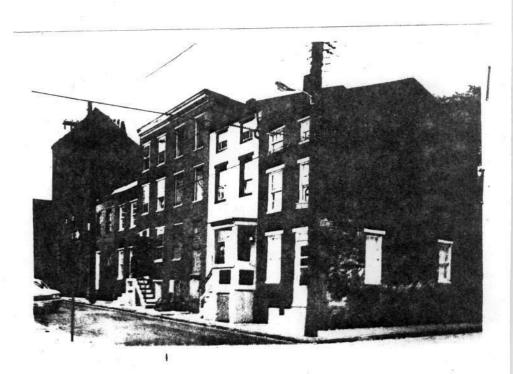
The old warehouse with a shed roof is gutted and dangerous. The other buildings are potentially an attractive group if repaired.

Numbers 1022 and 1030/1032 are vacant with the latter in the hazardous category. There is a row opposite, narrow street. (See comment for 1000-1016 Boyd Street.)
